Manhole Inspection Summary

Manhole # S49I__018MH

Insp Date: **4/1/08 10:30 AM**

Location Address: **2525 S Rose St**

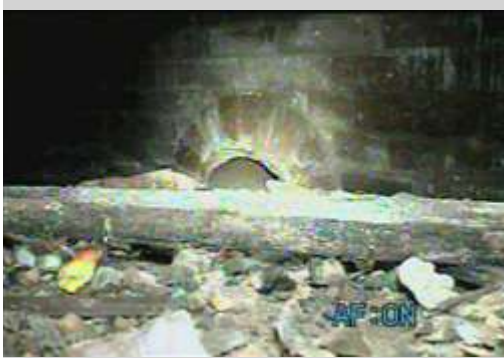
Defect 2

Bench ☒ Exists Material: **Brick** ☐ Parged

Condition: ☐ Sound ☐ Cracked ☐ Root Intrusion ☐ Deteriorated ☐ Leaks ☒ **Debris**

bench debris

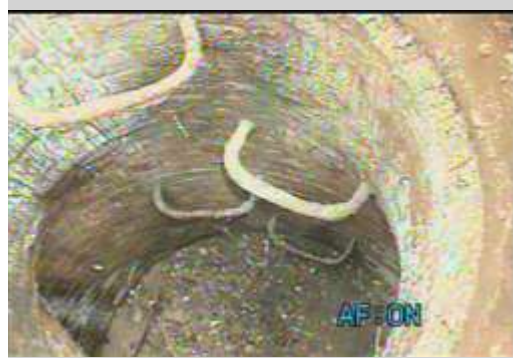
Defect 1

Infiltration: ☐ None ☐ Joint ☐ Cracks ☐ Mortar ☐ Roots ☒ **Wall**

Steps Count: **4** Missing: **0** ☒ **Corroded**

corbel wall infiltration, corroded stairs

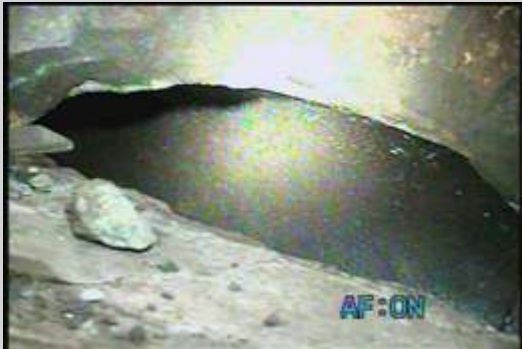
12 O'Clock Outflow

8 in. Circular Gravity Sewer
Pipe Out @ 12 O'Clock

pipe was off set and pics were difficult to take

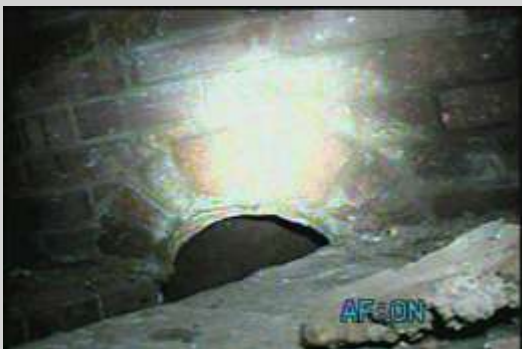
3 O'Clock Inflow

8 in. Circular Gravity Sewer
Pipe In @ 3 O'Clock

pipe off set
